Manhole Inspection Summary

Manhole # S21GG_012MH

Insp Date: **6/19/07 2:03 PM**

Location Address: **1500 PRESSER CT**

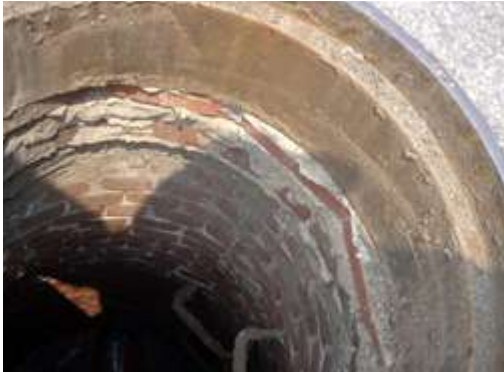
Defect 2

Offset: **1** (in.)

FRAME OFFSET

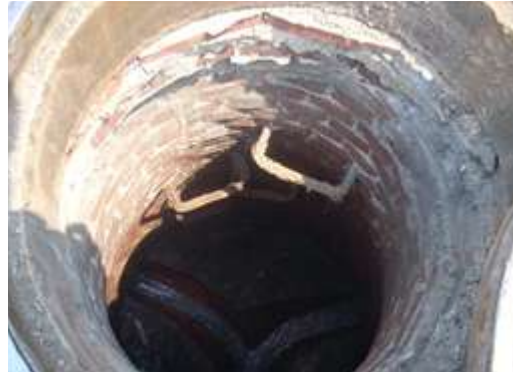
Defect 1

Count: **5** Missing: **0** ☒ **Corroded**

CORRODED STEPS

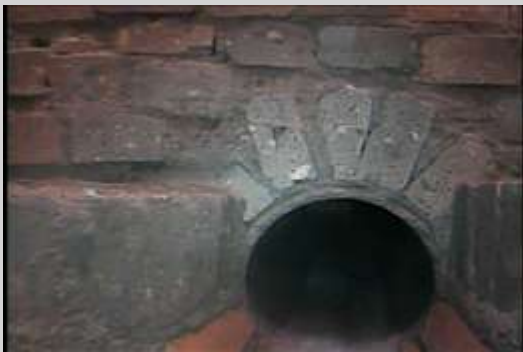
12 O'Clock Outflow

8 in. Circular Gravity Sewer
Pipe Out @ 12 O'Clock

Pipe Height: **8.4** (in.) Rod and Bar (Angled)
Pipe Material: **Clay** ☐ Pipe Lined
Invert Depth: **10.43** (ft.) Flow Characteristics: **Slow**
Deposits: ☒ None ☐ Mud ☐ Sludge ☐ Debris ☐ Grease
Silt Depth: (in.) Deposits Extent:
Infiltration: **None** Pipe Seal Cond: **Sound**

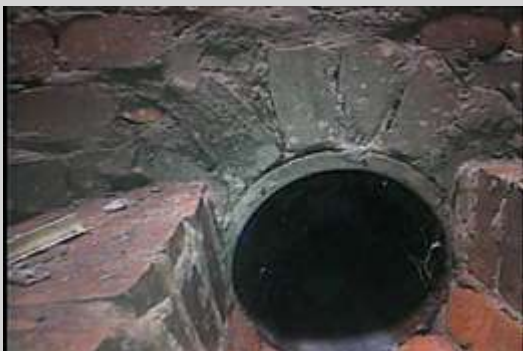
4 O'Clock Inflow

8 in. Circular Gravity Sewer
Pipe In @ 4 O'Clock

Pipe Height: **8.4** (in.) Rod and Bar (Angled)
Pipe Material: **Clay** ☐ Pipe Lined
Invert Depth: **9.88** (ft.) Flow Characteristics: **Slow**
Deposits: ☒ None ☐ Mud ☐ Sludge ☐ Debris ☐ Grease
Silt Depth: (in.) Deposits Extent:
Infiltration: **None** Pipe Seal Cond: **Sound**

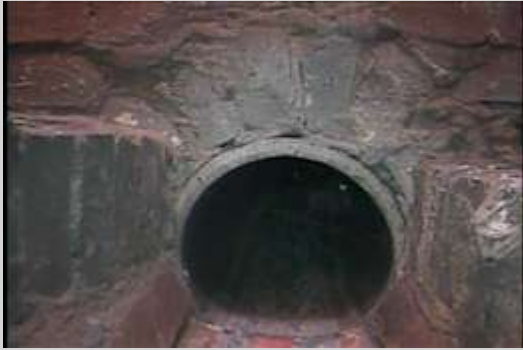
9 O'Clock Inflow

8 in. Circular Gravity Sewer

Pipe In @ 9 O'Clock

Infiltration: **None** Pipe Seal Cond: **Sound**
